Horn Troubleshooting

Ultrasonic Welding

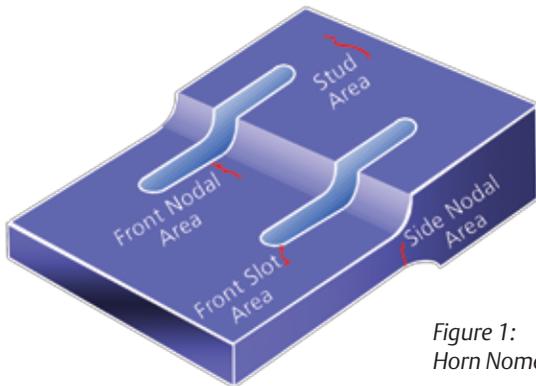
Figure 1:
Horn Nomenclature

- 4.** When a loud, high-pitched noise occurs, it may indicate a failed horn. First make a visual check to see if a crack can be located. Primary areas for inspection are the nodal area of the horn, the slot ends which are high stress areas, thin sidewall areas, and the stud area of the horn.

If no visible cracks are located, a light feel test will detect any “hot spots” on the horn surface. High stress will cause these hot spots, as will the friction of high frequency vibration in a cracked area. *The equipment should be turned off before conducting the feel test to avoid possible injury. Please use caution, because the vibration friction can create high temperature spots at the crack locations.*
