**DEVELOPMENT OF A CAVITATION EROSION RESISTANT
ADVANCED MATERIAL SYSTEM**

A THESIS

Master of Science

The University of Maine

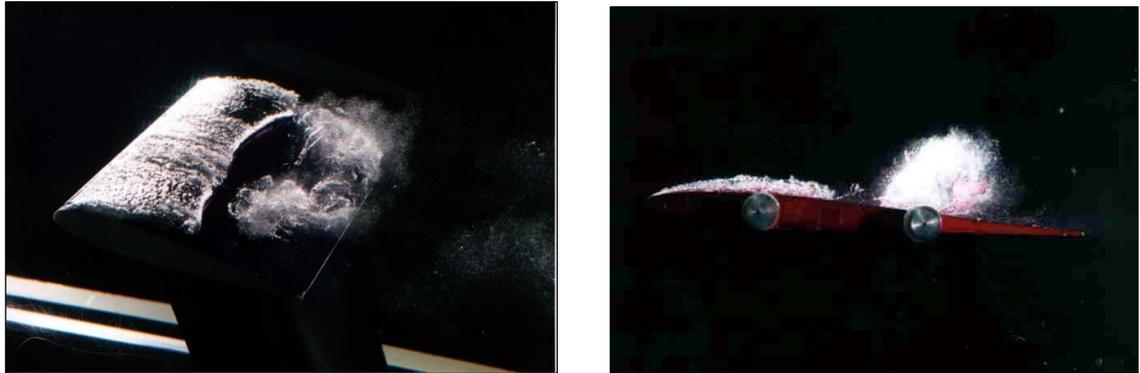
**Figure 1.1 - Photographs of cavitation generated by high speed lifting body shapes.
[University of Tokyo]**

There is a current need to evaluate the cavitation erosion resistance of materials and protective systems for advanced ship hull sections. Examples of the cavitation generated by moving bodies due to geometric shape changes are illustrated in Figure 1.1. The damage and material loss caused by cavitation erosion of naval surface vessels has traditionally only been seen in the areas of the propeller and rudder components. These components are typically constructed from relatively cavitation resistant materials such as stainless steel or NiAl (Nickel Aluminum) bronze. Both of these materials have a long history of being used in cavitating environments and are repairable when damage does occur. The downfall of these materials however is their excessive weight when evaluating these materials for the construction of a complete high-speed hull form. Most

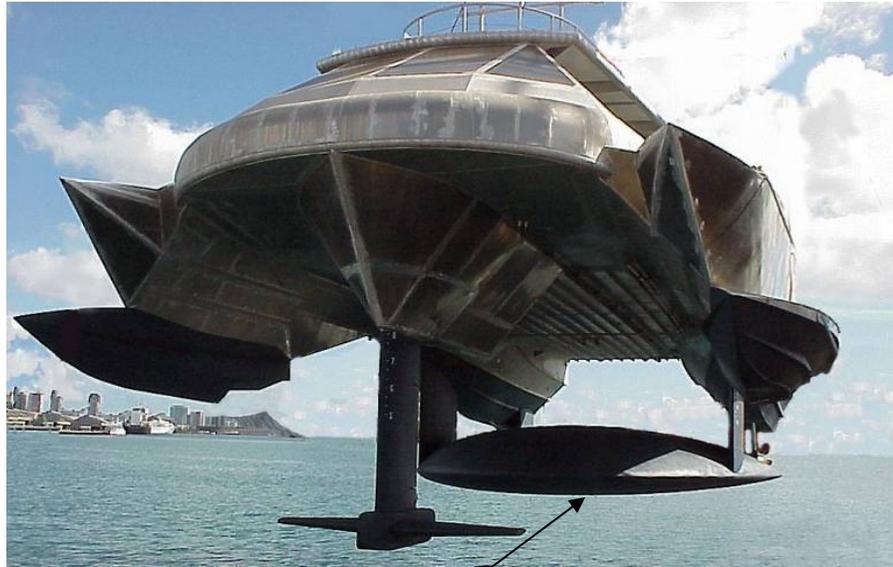
Parabolic underwater lifting body

Figure 1.2 - Midfoil Craft with Underwater Lifting Body

Figure 1.2 shows one example vessel called the MIDFOIL developed by Navatek where a hydrofoil and a parabolic lifting body shape are combined with a catamaran hull to achieve additional buoyancy and dynamic lift which greatly improves the performance and sea-keeping of the vessel. Relatively inexpensive pilot tests on the MIDFOIL and similar vessels have shown that this method has great advantage for fast military support craft and commercial vessels such as ferries. Recent studies have shown that the addition of underwater bodies can dramatically improve speed, reduce fuel consumption and increase payload. These efforts have also demonstrated that composite material construction can bring about increased structural efficiency.

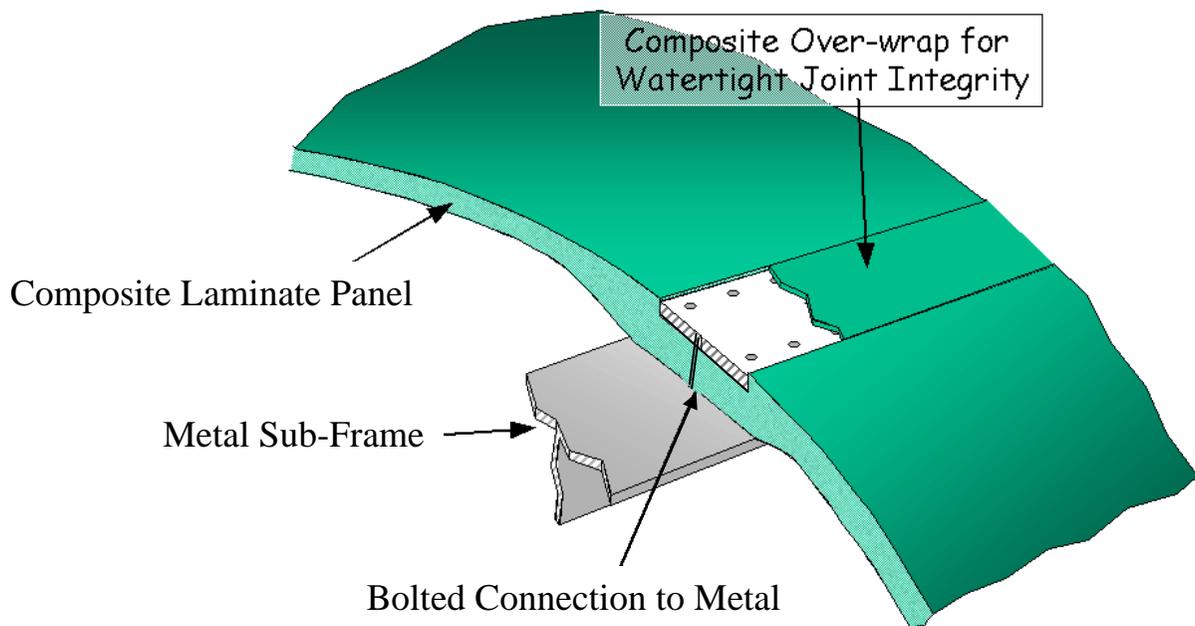
Figure 1.3 - Hybrid Structure Constructed Using GRP Composite Skin Over Metal Substructure

The method proposed for construction of a composite/metal hybrid version of the underwater lifting body is to use a skin made of composite materials attached to a metal framework. Figure 1.3 shows a schematic of this concept. This type of system will allow for ease of maintenance of equipment housed inside the lifting body and it will provide a metal skeleton to facilitate attachment of propulsion equipment. The skin design is of monocoque, stiffened or sandwich construction depending upon structural requirements. It is subsequently attached to the metal structure using a hybrid connection. Detailing this connection to have adequate strength and watertight integrity is imperative.

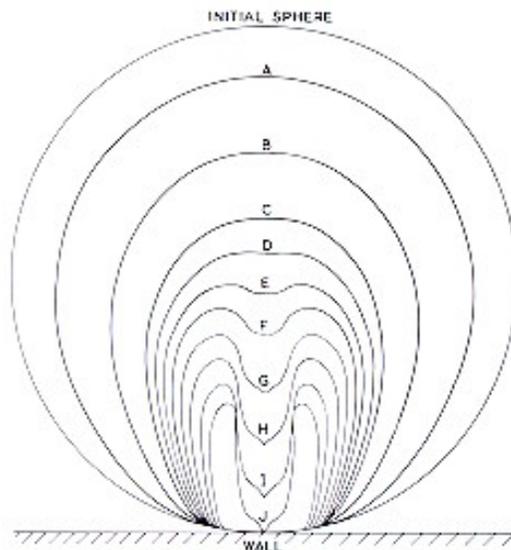
Figure 2.1 – Schematic of asymmetrical bubble collapse showing liquid jet impingement [Morch, 1979]

perfectly symmetrical collapse. This asymmetry greatly complicates the bubble collapse dynamics and results in the formation of a liquid jet by the collapsing bubble surface. This jet is illustrated in Figure 2.1 and shown in-situ in Figure 2.2. If the bubble is near a solid boundary, then this liquid jet acts as a “water hammer” against the surface. Combined with the typical shock wave during collapse, both of these mechanisms can result in damage to the structure. Most researchers, however, credit the liquid jet as being the major damage mechanism. In addition to the effect of a single bubble collapse, the idea of magnification in impingement pressure due to the cumulative collapse of a cloud of bubbles has been reported as providing as much as a ten fold increase in pressure. Pressures on the order of 900 MPa have been reported at the surface near a cavitation cloud [Morch, 1979]. The effect of this phenomenon on ductile materials is a local strain hardening at the site and an eventual fatigue failure of the material [Veerabhadra Rao et al., 1981]. Further exposure beyond this incubation period leads to cracking and loss of material.

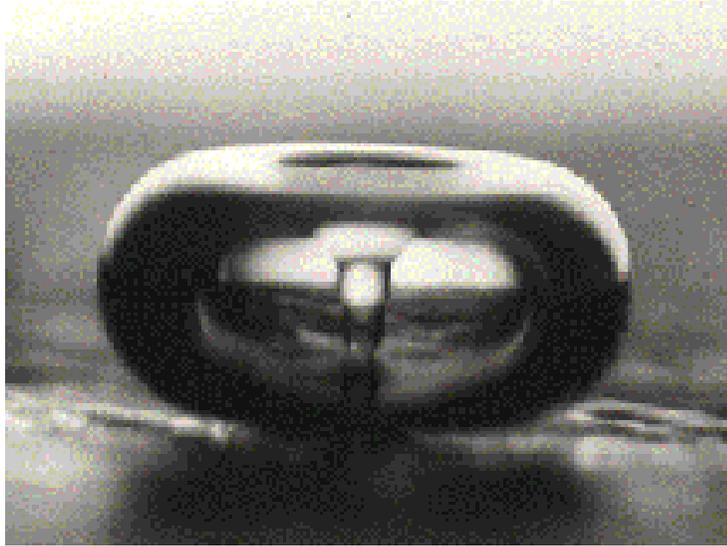
Figure 2.2 - Photograph of actual collapsing cavitation bubble. [Center for Industrial and Medical Ultrasound, University of Washington]

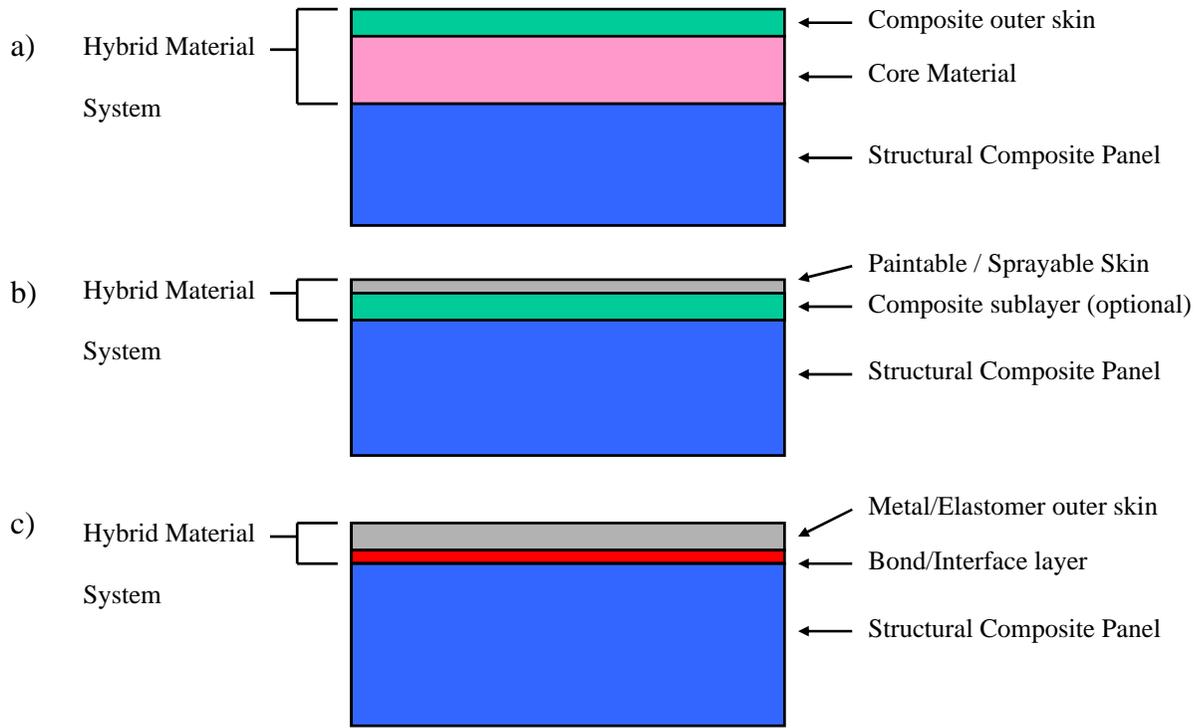
Figure 3.1 – Schematic representation of different types of material systems

The cavitation erosion resistant material system used in the underwater lifting body is intended to be a nonstructural outer layer of the composite substrate. Figure 3.1 schematically shows a number of different potential material systems investigated. These include a durable composite outer skin with or without an energy absorbing core material (Figure 3.1a), a durable composite skin with a thin layer protective coating (Figure 3.1b), and a metal or elastomeric skin applied directly to the structural composite substrate (Figure 3.1c). These material systems are arranged in their relative order of risk versus reward based on potential nonstructural weight added to the system, compatibility and post lay-up manufacturing considerations. It is generally agreed that a durable composite material system will be the most difficult to realize when compared to more traditional metallic solutions yet it will offer the greatest potential rewards with respect to weight savings.

The third material system concept depicted in Figure 3.1c consists of a thin metal skin applied over the base structural composite. Materials considered for this protection system included NiAl bronze (propeller bronze), 316L stainless steel and two highly corrosion resistant duplex stainless steels, ferralium (alloy 255) and Zeron[®] 100. Ferralium is a high strength, corrosion resistant stainless steel produced by Langley Alloys of Staffordshire England. Zeron[®] 100 is a similar grade of material produced by Weir Materials and Foundries in Manchester England. Drawbacks to the implementation of this system include the added weight, formability concerns with complex curves and the difficulty of adequately bonding the metal to the composite substrate. No specific testing or evaluation was undertaken to evaluate these factors. If this type of system were implemented, it is most likely that these metallic protection panels would only be applied to the areas most prone to severe cavitation attack. The results for these materials are given in Chapter 5.

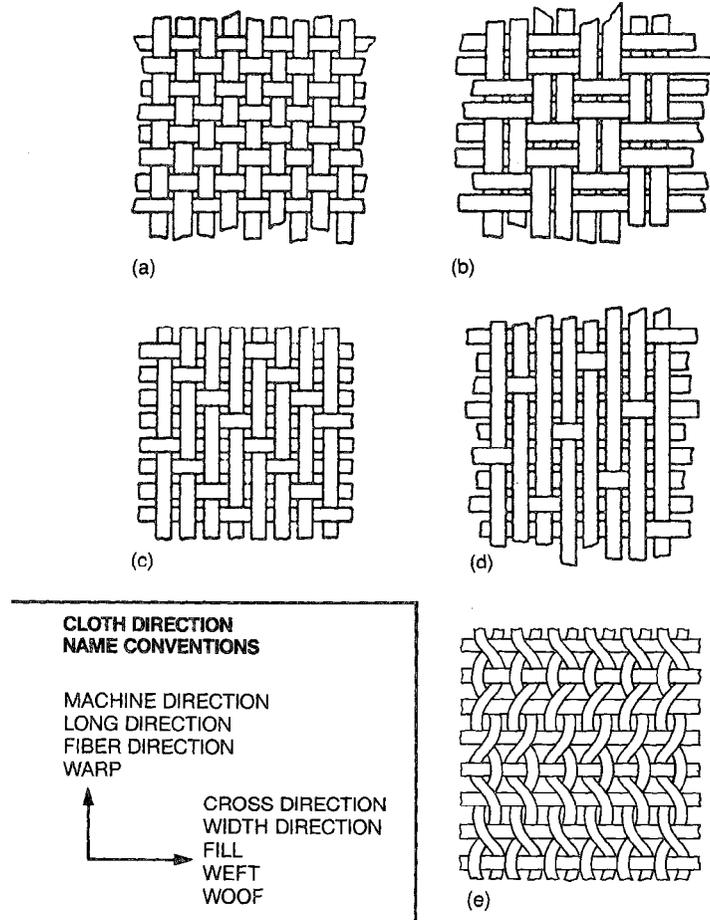
Figure 3.3 - Laminate weave geometries [Strong, 1989]

The laminate geometry implies a mixture of ply thicknesses (thick or thin), ply orientations and weave geometry. Figure 3.3 depicts typical weave patterns for composite fabrics. The custom weaves used in the carbon fiber, HPQY, and combination carbon/HPQY were all harness weaves as depicted in (d). Specifics of the various laminate geometries are listed in Table 3.4. As cited by Hammond, the common failure mechanism for composites is the erosion of the matrix around the fiber bundles which eventually leads to subversion and fiber breakage. It is possible that different weave densities and/or geometries could influence this behavior by more closely packing the fiber reinforcement. Although this methodology was not specifically tested during this study, inherent size differences of the different fiber bundles does provide some empirical

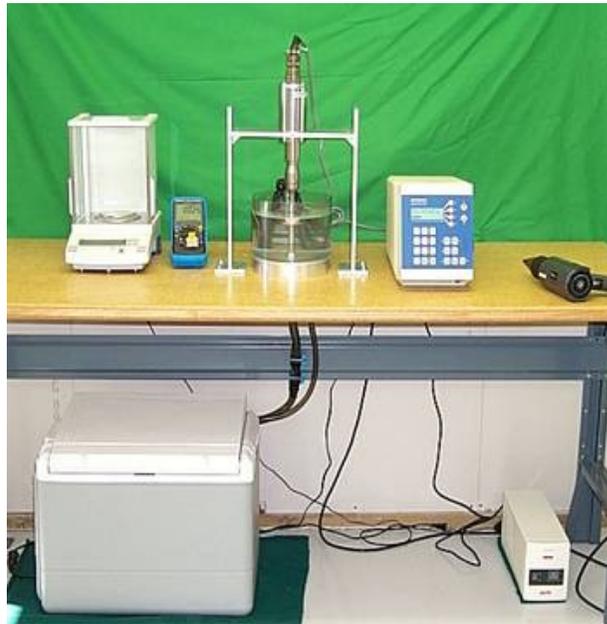
Figure 4.1 – Photograph of the experimental test apparatus

The ASTM G32-98 test method utilizes a commercially available ultrasonic transducer, which is attached to a tuned “horn” oscillating at 20 kHz. The particular ultrasonic equipment used is a Branson Ultrasonic Digital Sonifier model S450D as shown in Figures 4.1 and 4.2. The replaceable horn tip is constructed of Ti-6Al-4V. The tip of the

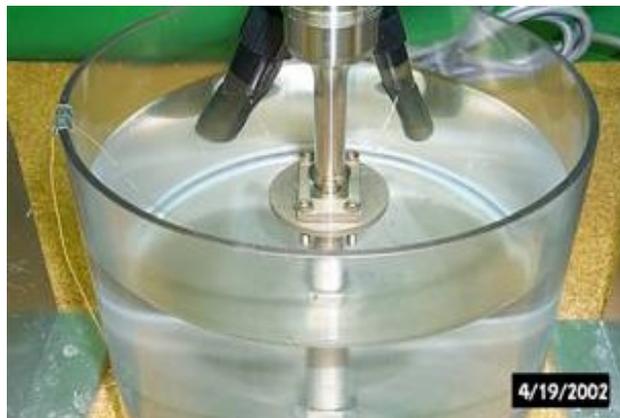
Figure 4.2 – Close-up photograph of the specimen holder

horn oscillates above the test sample at a precisely controlled distance and produces cavitation bubbles that impinge on the surface. The peak-to-peak tip displacement is OEM calibrated and adjustable on the amplifier. It is set to 0.050 mm for these tests. The test sample is mounted 0.50 mm away from the oscillating tip. Bulk fluid temperature in the container is maintained at 23-27° C by the use of a cooled water recirculation system. The temperature is monitored by a thermocouple in the tank. The erosion rate of the material is determined by periodically stopping the test and drying and weighing the sample. Weight was taken using an Ohaus Adventurer scale that has a 65g capacity and a precision of 0.0001g. The testing method is calibrated periodically using standard 6061-T6 Aluminum or Ni 200 as a reference material.

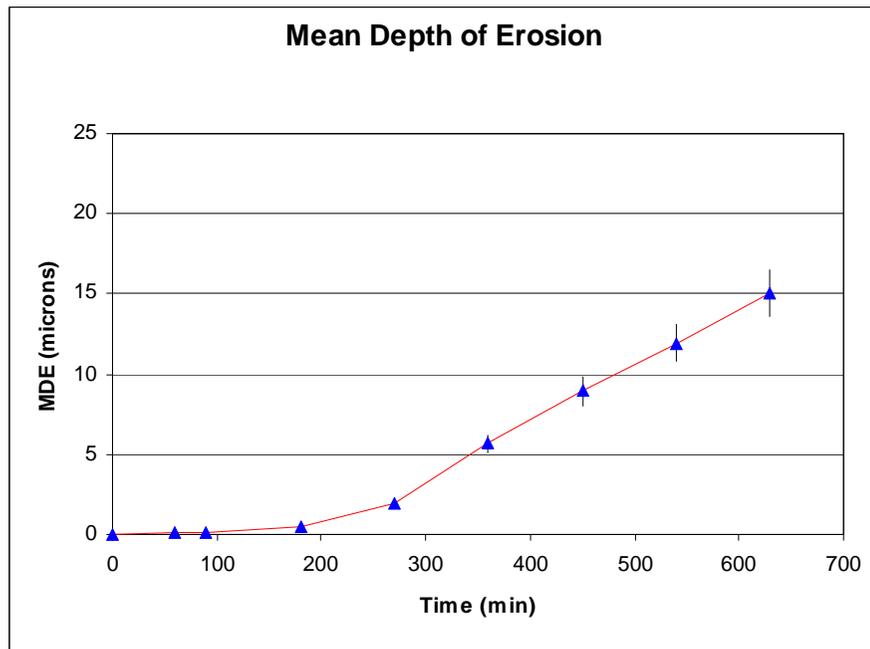
Figure 4.3 - Example Cumulative Erosion-Time Curve

A typical MDE curve from a metallic sample is shown in Figure 4.3. Given the shape of the cumulative erosion-time curve, it is not meaningful to compare the absolute MDE for different materials after the same exposure time. The reason is that a selected time may still be within the incubation or acceleration stage for a very resistant material, whereas for a weak material the same time may be within the maximum rate or deceleration stage. The most common single-number for comparison of different materials is the maximum rate of erosion. This can be defined as the slope of the straight line that best approximates the linear, (or nearly linear) steepest portion of the MDE curve and is expressed in micrometers per hour.

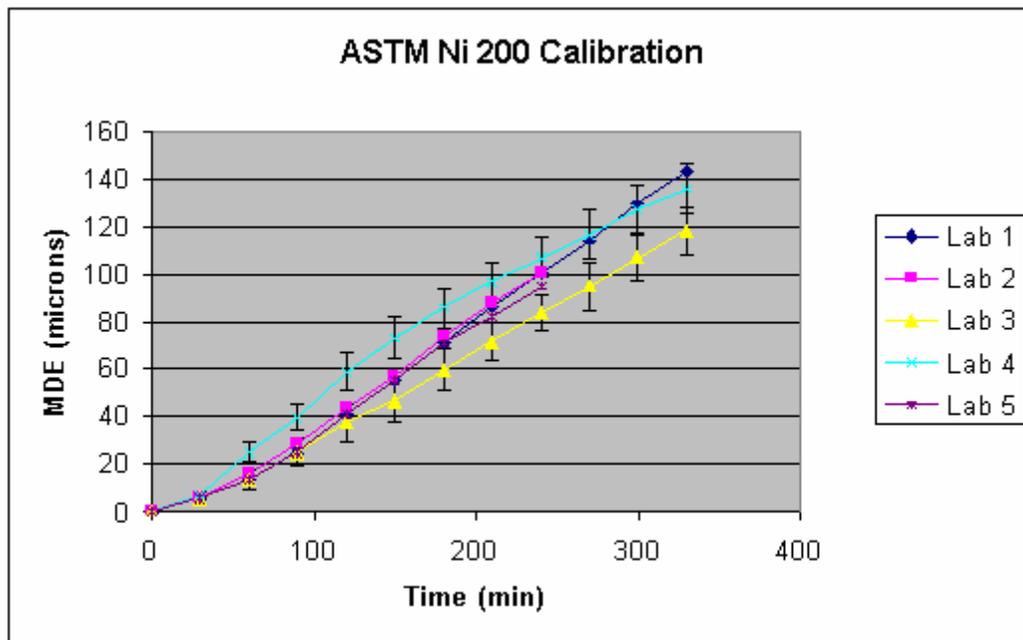
Figure 4.4 - MDE for Ni 200 from independent lab tests using ASTM procedures

The ASTM G32 standard recommends calibrating the test apparatus and procedures using a Nickel 200 material and comparing the results with those provided in the standard. The standard lists results from five independent labs and these are shown in Figure 4.4. The error bars on the curves represent a single standard deviation.

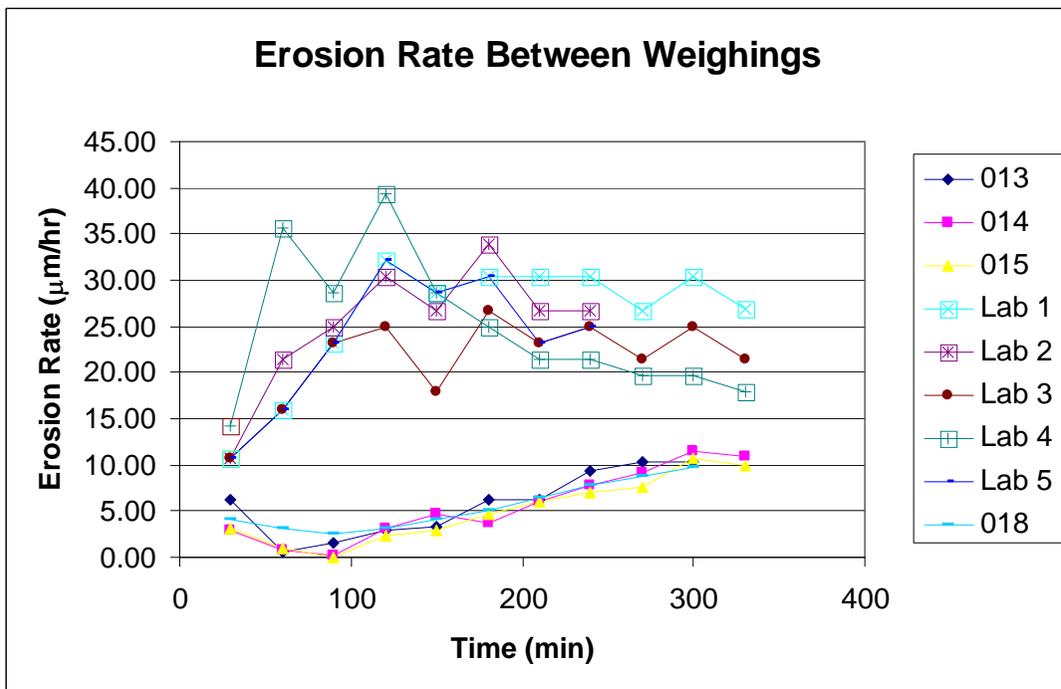
Figure 4.5 – Erosion rate of Ni 200 samples Using Modified Procedures

The results of testing Nickel 200 with the modified procedures are presented in Figure 4.5. Also plotted are the erosion rate results from the calibration lab data. This plot highlights a discrepancy in the data between the two methods. Although the data from the modified test method appears to be repeatable between tests, the erosion rates calculated are much lower than those provided by the ASTM standard data. Several reasons for these discrepancies have been identified. The area of the cavitating horn tip in the standard is larger by a factor of 2.3 than that used in the modified test. The tip area will affect the overall mass loss area and thus the reported quantity of MDE. In an effort to account for this difference, the results for the calibration tests have been normalized with respect to tip area and are compared in Table 4.1. The results show that the

normalization process provided starting values of MDE that are comparable; however, the results from intermediate times vary significantly. Part of this trend can be attributed to the drop in erosion rate of our test samples shown in Figure 4.5. The difference in horn tip area could also cause a difference in cavitation intensity under the horn. As outlined in the theory section, the force imparted on a substrate by a cloud of bubbles is much greater than the force from a single bubble. Given this behavior, it does not seem unreasonable that the cavitation cloud under a larger horn tip may be more intense and result in more damage to the material. It is also possible that an unidentified material discrepancy exists in the tested nickel samples. In any case, further efforts to correlate data between the modified testing method and that of the standard method were not pursued. The following section will discuss the repeatability testing that was done on the modified testing method. Given the fact that this effort seeks to rank each material's relative erosion rate, it was determined that repeatability of the method was the most important aspect of the test method.

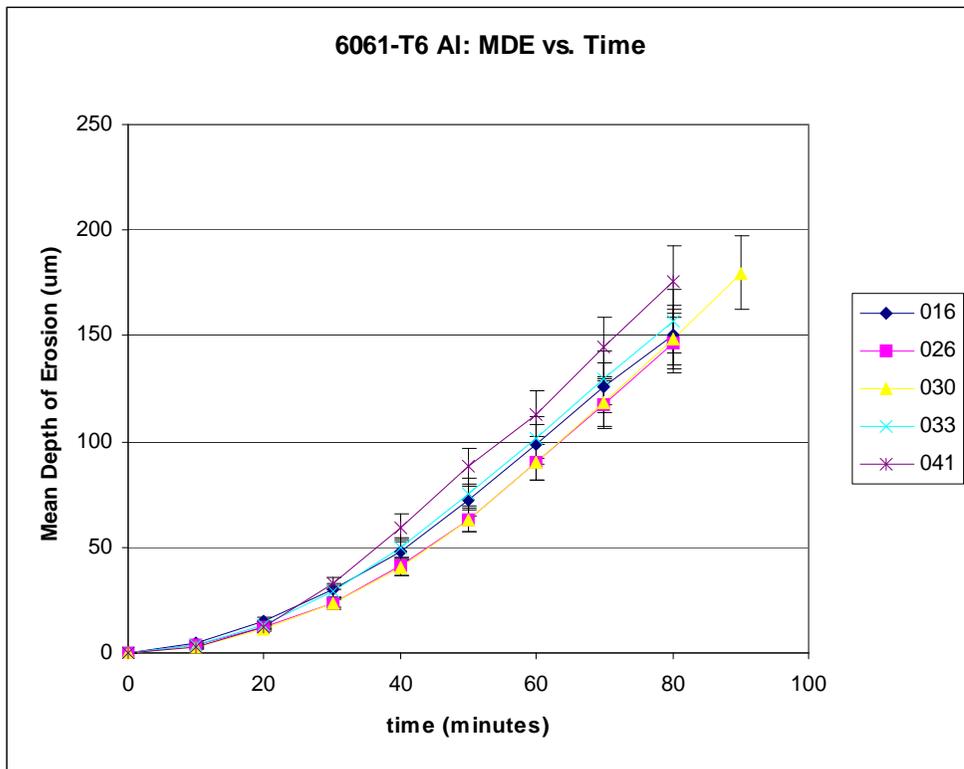
Figure 4.6 – Repeatability of 6061-T6 Aluminum Samples

Since current testing focuses on obtaining relative rankings of cavitation resistance, repeatability was determined to be more critical than the ability to correlate test data with data found in published sources. 6061-T6 aluminum was chosen as the standard for checking the consistency and repeatability of the test method because of its higher availability and shorter test times than Nickel 200. Figure 4.6 shows the cumulative mean depth of erosion (MDE) curves for multiple aluminum samples. As can be seen from the plot, all test data points are within one standard deviation of each other as shown by the error bars. By periodically running one of these samples throughout the testing, it is ensured that the test apparatus and test method remain reliable and provide consistent relative data for the erosion rate of different materials systems.

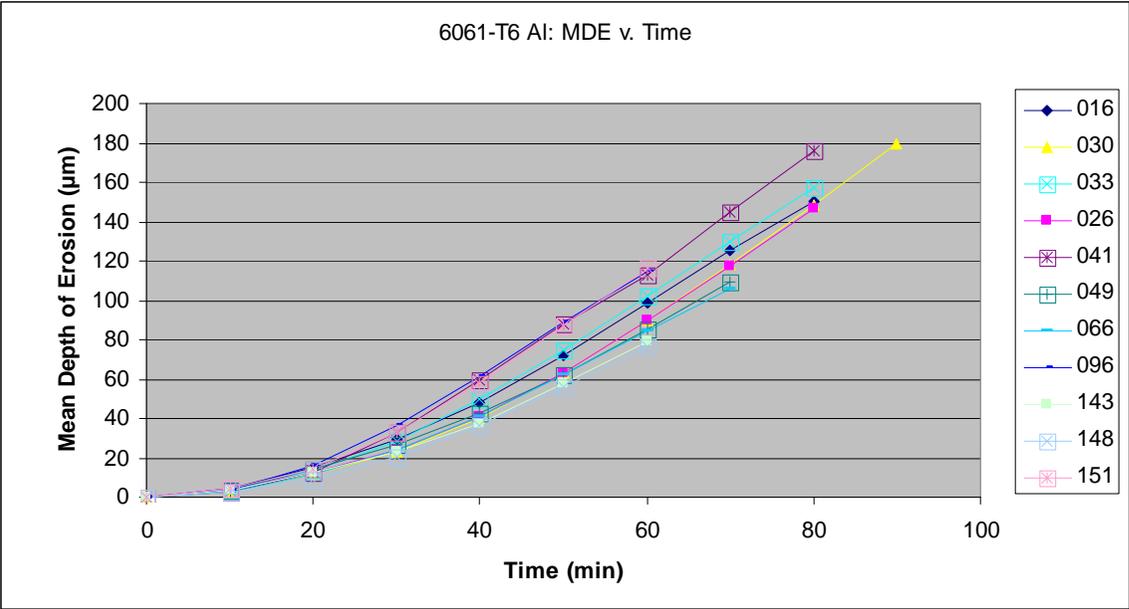
Figure 5.1 – Plot of MDE versus time for all Aluminum 6061-T6 samples

Figure 5.1 shows a plot of all the aluminum samples tested. Eliminating the highest and lowest values from tests #109 and #147 respectively, the average erosion rate is 152 $\mu\text{m/hr}$. It should be noted that test #041 and test #151 used opposing sides of the same sample. Very good agreement is shown in the erosion results between these tests. Figure 5.2 is a typical example of the excessive damage of aluminum samples. Given its low damage tolerance, this material would not be a good choice in a cavitating environment.

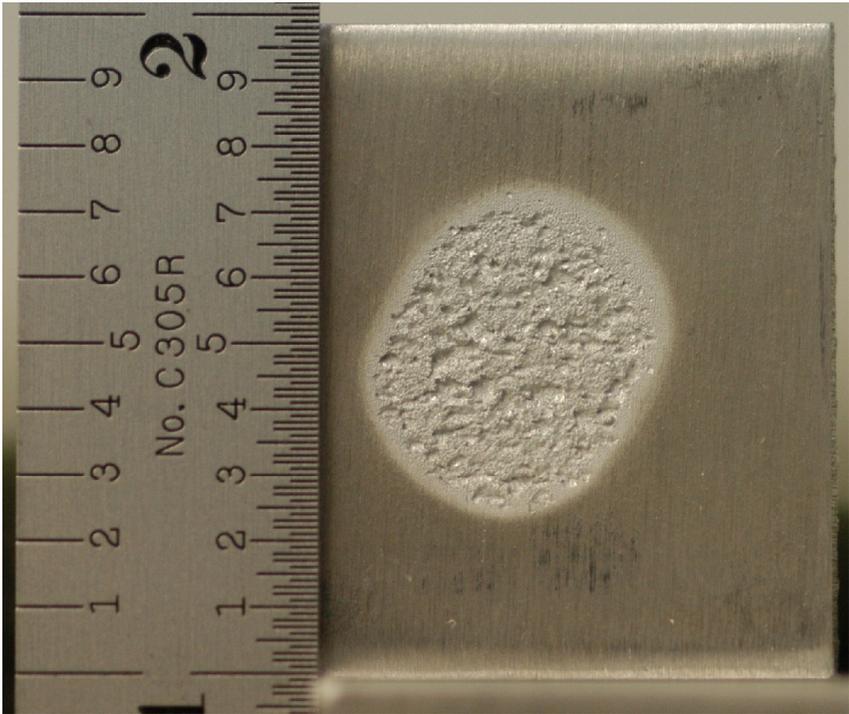
Figure 5.2 – Photograph of aluminum 6061-T6 sample #096 after testing

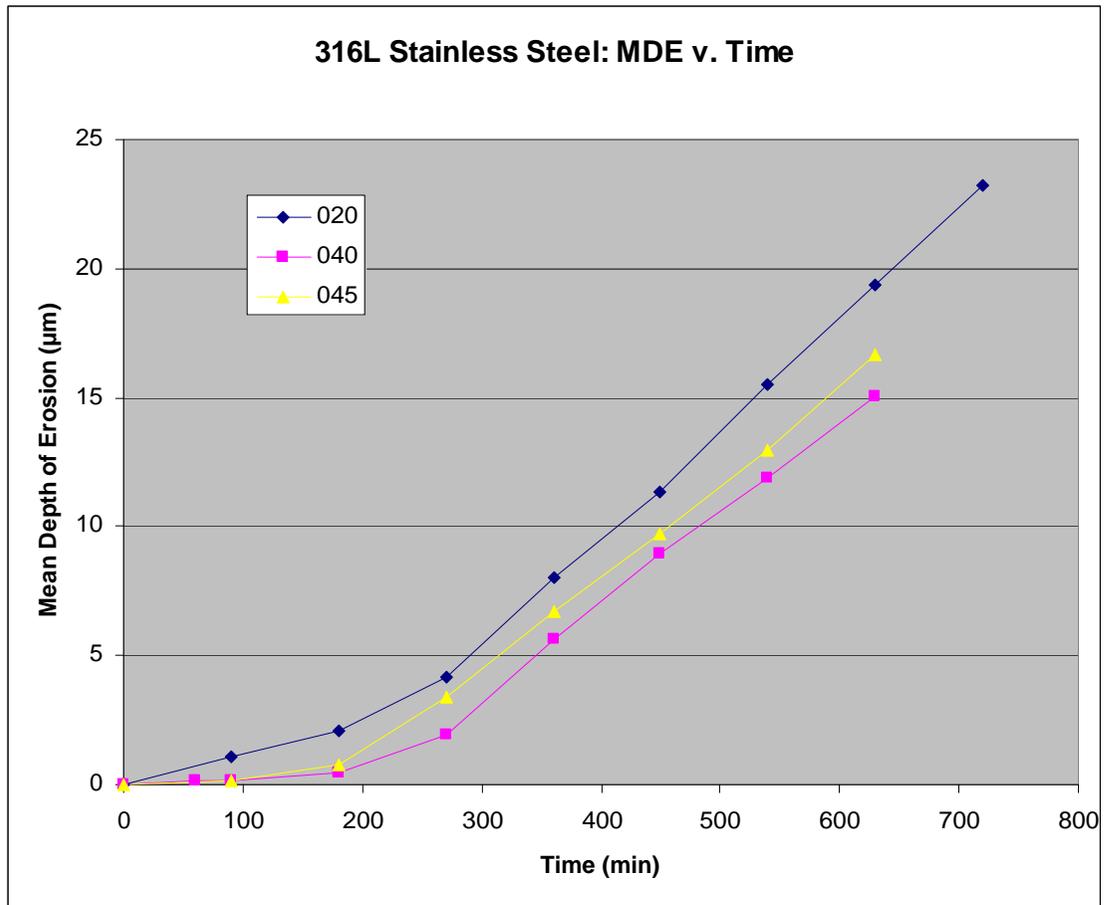
Figure 5.3 – Plot of MDE versus time for 316L stainless steel samples

Figure 5.3 shows a plot of the three 316L stainless steel samples tested. Figure 5.4 shows the damage to sample #040 which is typical for these materials. When compared with the aluminum, the stainless samples exhibit much less pitting and less overall mass loss. The remaining structural materials, NiAl bronze, ferralium, Zeron 100, AL6XN and titanium all fall within 0.65 $\mu\text{m/hr}$ of each other as depicted in Figure 5.5. Each of these materials shows similar damage patterns to that of 316L stainless steel. Based on this data, it appears that any of the stainless steels tested would provide a good cavitation erosion resistant material. If weight is a primary concern, then titanium may be a good choice.

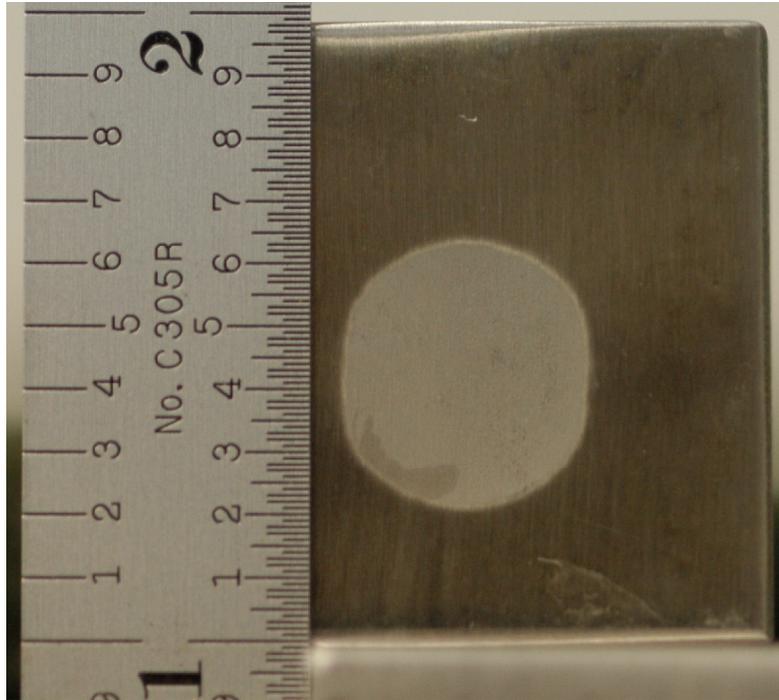
Figure 5.4 – Cavitation damage of a 316L stainless steel sample #040

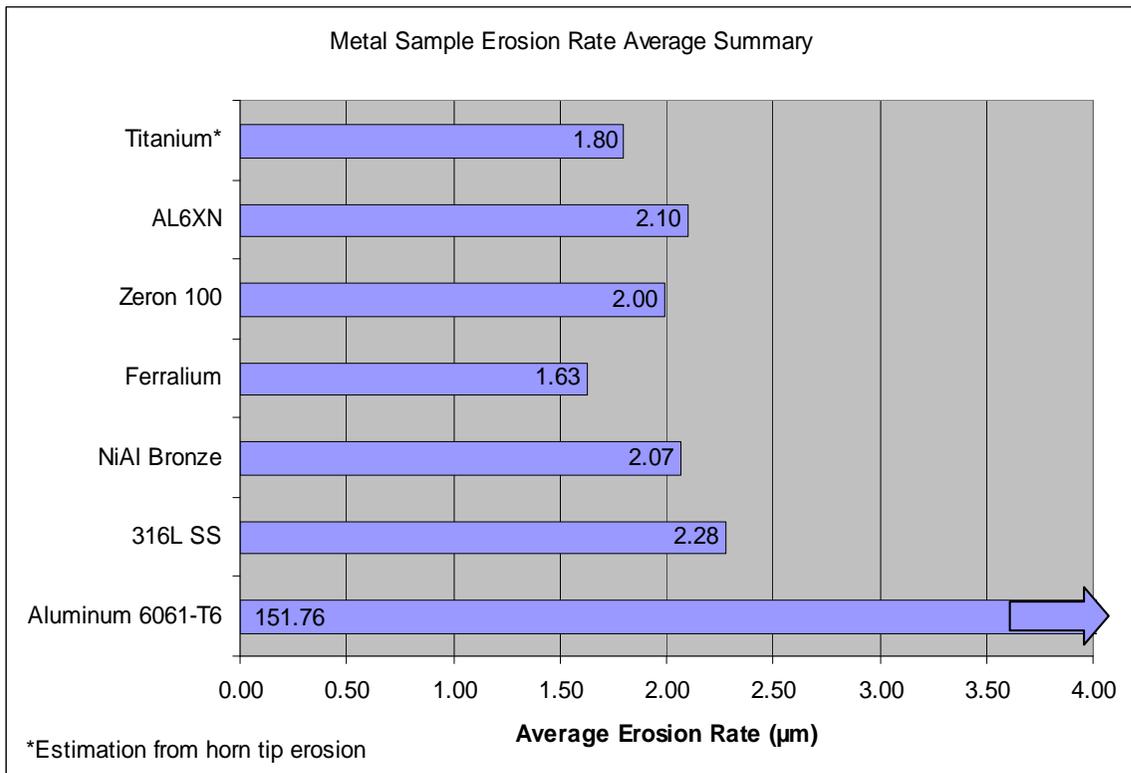
Figure 5.5 – Summary results of cavitation resistance of candidate metal samples

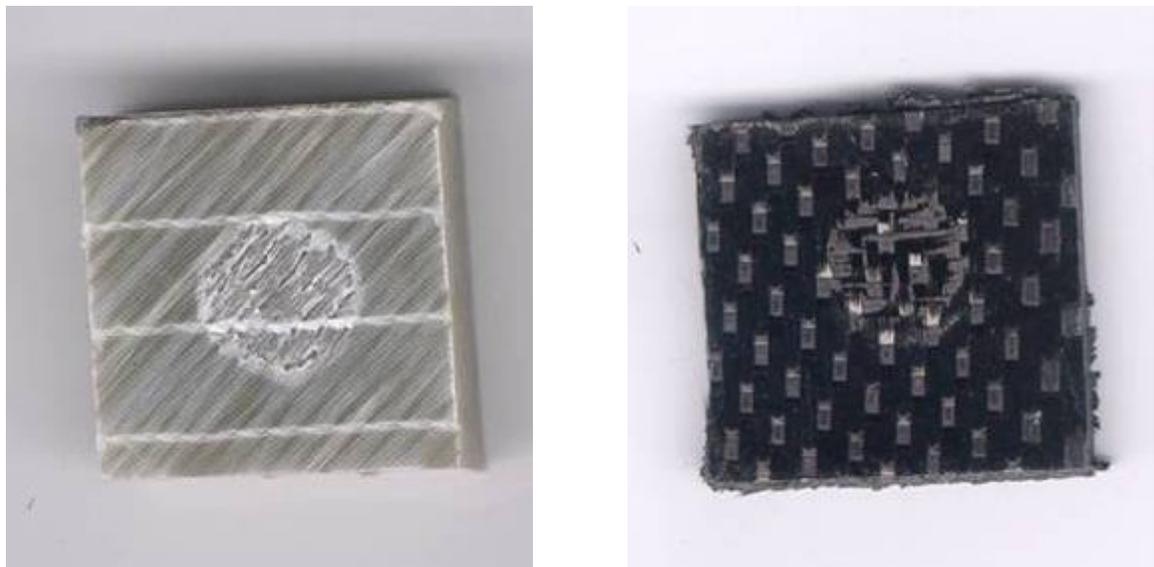
Figure 5.6 – Test sample of E-glass/8084 (left) and Carbon/8084 (right) showing matrix and fiber erosion

The search for a durable composite outer skin proved to be difficult. The primary mechanism of failure as discussed in Section 2.5 is matrix erosion followed by fiber damage. This damage mechanism is evident in Figure 5.6 regardless of fiber type. A summary of the erosion rate results for the composite samples is presented in Figure 5.7 and shows a wide range of values. The combination of carbon fiber and Derakane™ 8084 resin showed the worst results at 684 $\mu\text{m/hr}$. The choice of resin does have an

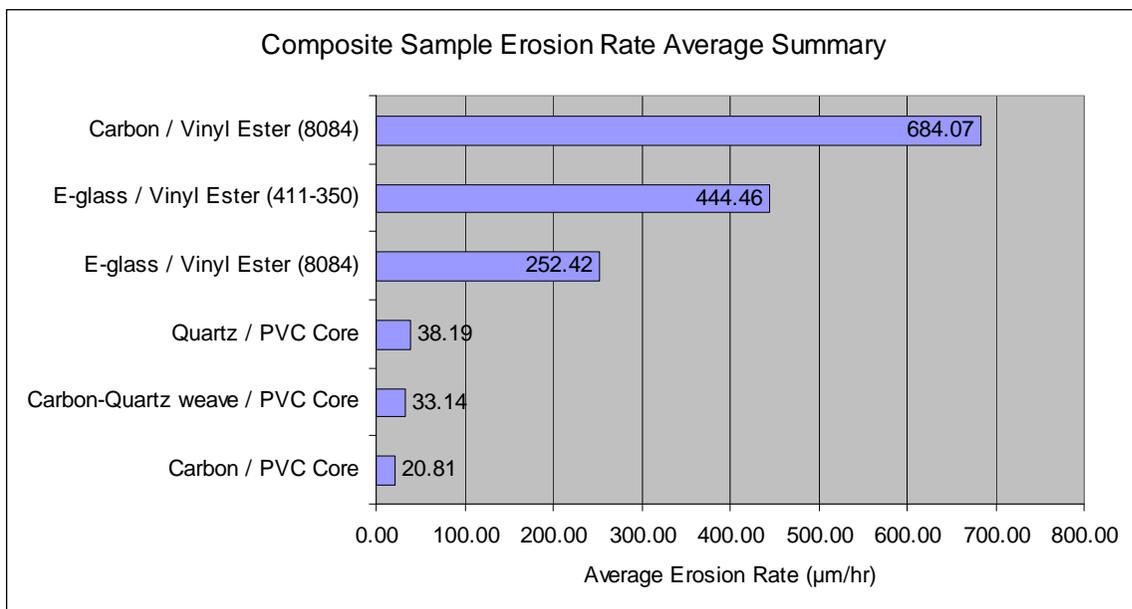
Figure 5.7 – Summary results of cavitation resistance of composite samples

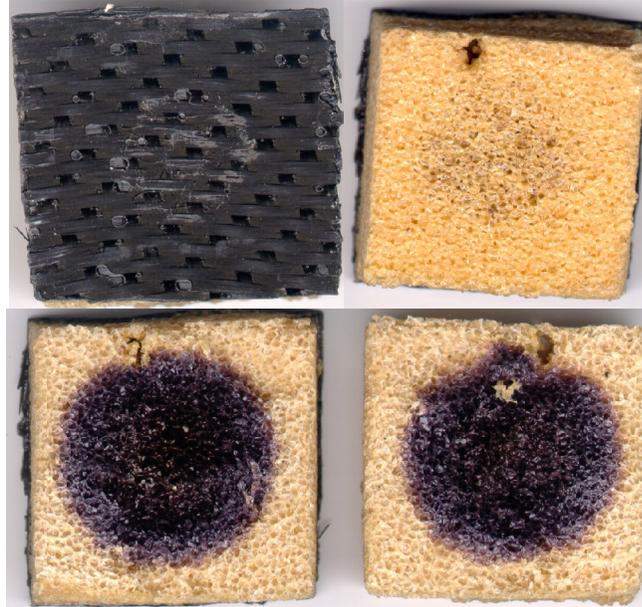
Figure 5.8 – Carbon fiber over PVC core samples showing core damage

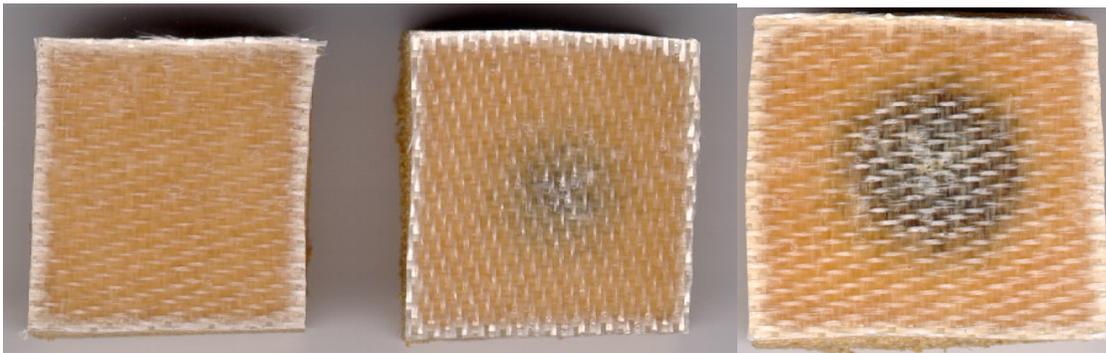
Figure 5.9 – Quartz fiber over PVC core sample showing core damage.

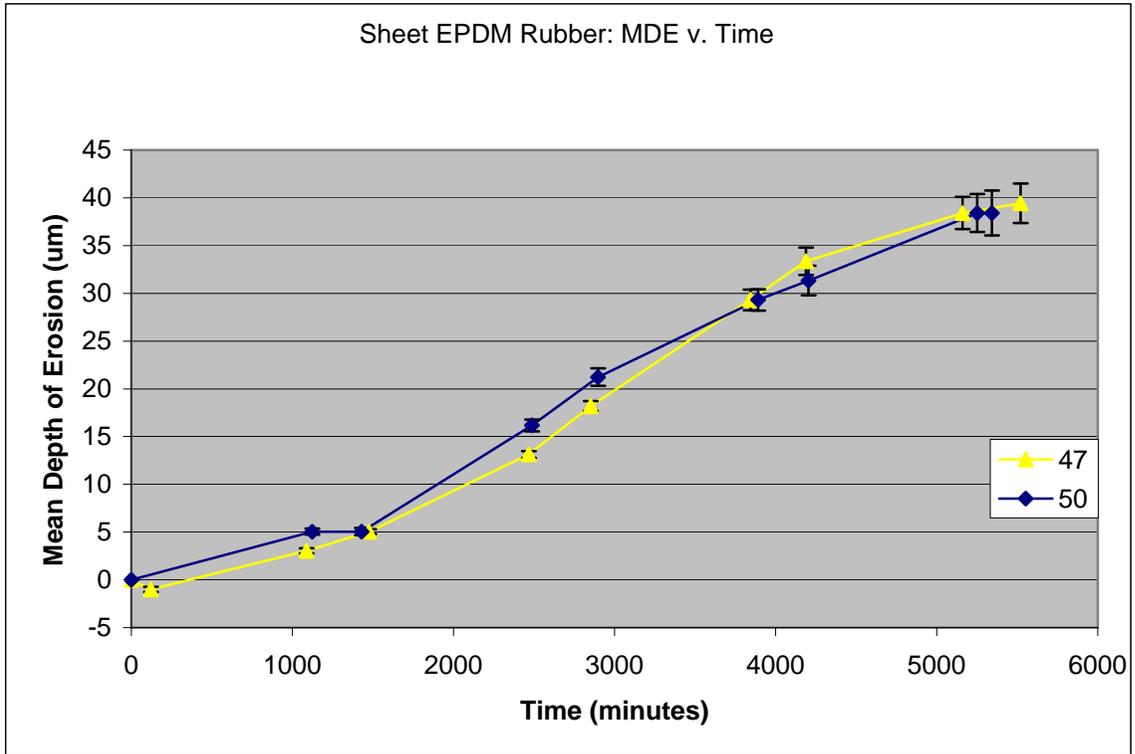
Figure 5.10 – Sheet EPDM results

for samples #047 and #050 are shown in Figure 5.10. The peak erosion rate for these samples did not occur until more than 1500 minutes (25+ hrs) of testing had occurred. Even though the results from the sheet EPDM rubber appear to be good, the manufacturing concerns of bonding a complex geometry with a continuous sheet material prompted an investigation into a paintable or spray on formulation. There exist a number of liquid EPDM rubber variants that are applied with brushes or rollers and only require a room temperature cure. The sample chosen for testing was Liquid Rubber™ from Pro Guard Coatings. Pro Guard Coatings supplies the roofing and other industries with easy to apply rubber formulations. The test samples from both sheet and liquid EPDM rubber are pictured in Figure 5.11. It should be noted that the pictures show damage after only 122 minutes for the liquid EPDM. A total of 5 liquid EPDM samples were tested and only sample #080 provided a reliable erosion rate of (80 $\mu\text{m/hr}$). The other four samples experienced premature delamination or severe pitting damage and loss of material. Discussions with Hal Gouldner [Gouldner, 2002] of Pro Guard Coatings indicated that previous in-house testing of their liquid EPDM formulations also produced poor results. The reason that he gave related to the molecular and surface bond strengths being inadequate. The difference between their product and sheet EPDM is the amount of cross-linking present due to the curing process. The Liquid Rubber™ EPDM is a non vulcanized cure at room temperature. Vulcanization is a chemical process by which the monomer base chains of the material are cross-linked. It is often done at elevated temperatures and in the presence of other chemicals that provide the chemical cross-link between monomer chains [Bhowmick et al., 2001]. Sulfur is the most common cross-link

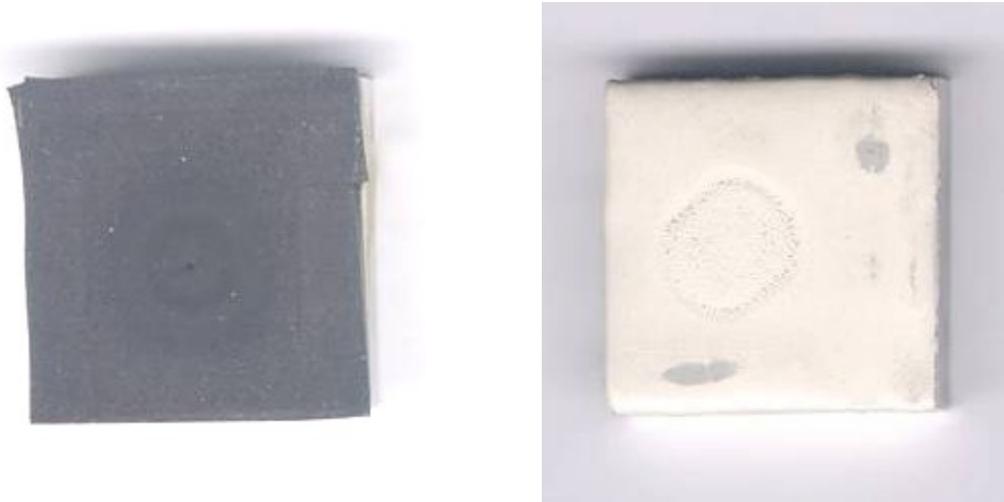
Figure 5.11 – EPDM rubber samples, sheet (left) and liquid (right)

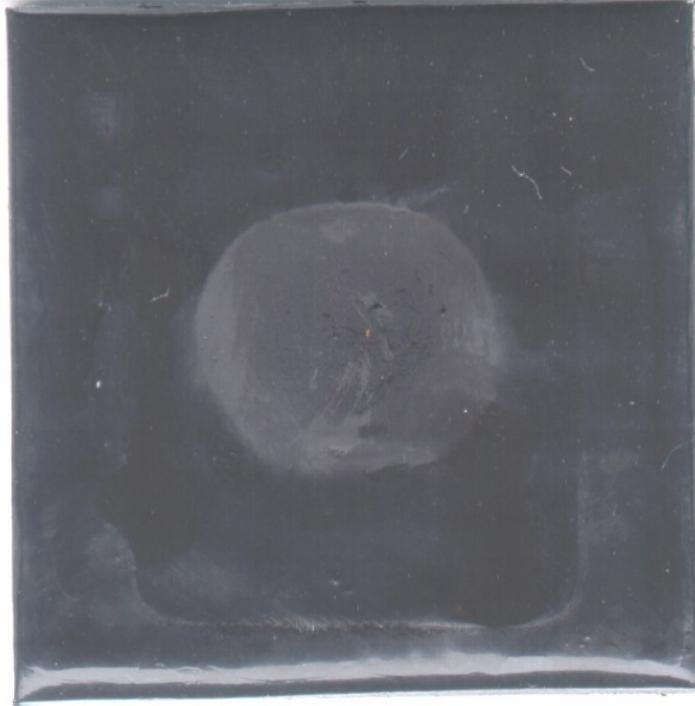
Figure 5.12 – PLV 2100 sample showing typical damage pattern

depicted in Figure 5.12. This usually resulted in more severe mass loss as testing continued. None of the samples tested resulted in an erosion rate better than that of 316L stainless.

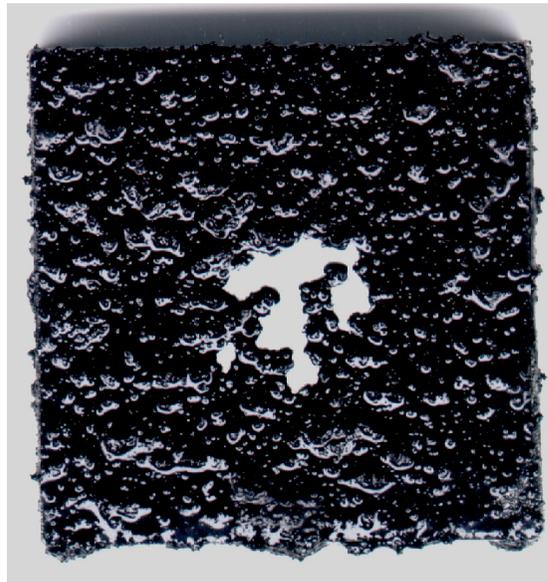
Figure 5.13 - Herculiner[®] sample #051 showing erosion damage

Otherwise, the samples were prepared per manufacturers specifications on an aluminum substrate. The average thickness was 0.028". The average erosion rate from sample #055 and #057 was 39.2 $\mu\text{m/hr}$. The failure mechanism in these samples was pitting and loss of the coating as shown in Figure 5.13.

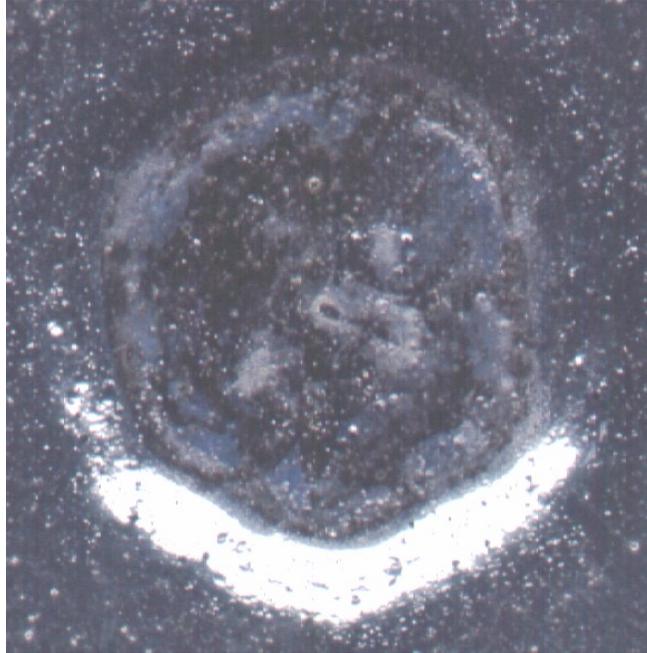
Figure 5.14 – Rhino Linings sample #110 showing typical damage including bubble formation under the horn tip

Rhino Linings[®] is a commercially available polyurethane truck bed liner from Rhino Linings USA, Inc. It is only available from licensed dealerships and is applied as a two-part spray. The samples were applied at the dealership onto an E-glass substrate. The average thickness was 0.0175". The average erosion rate from samples #137 and #138 was 22.4 $\mu\text{m/hr}$. The failure mechanism for this material was the formation of a bubble within the coating as shown in Figure 5.14. Dissection of the material revealed that the failure was caused by both delamination of the coating from the substrate and internal shear failure of the material.

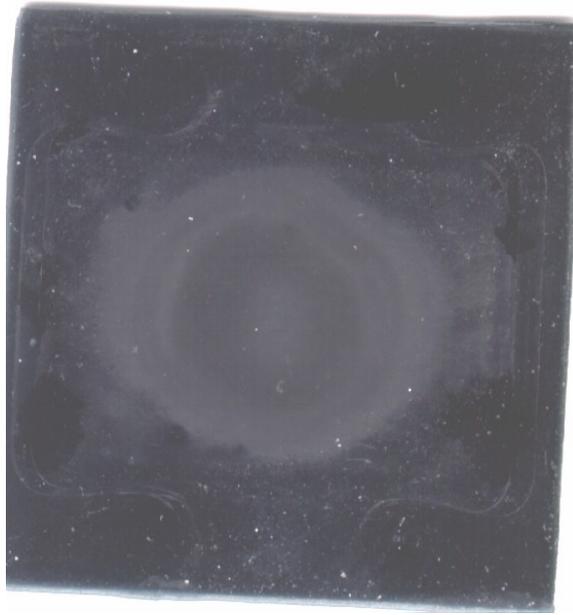
Figure 5.15 – Biocoat-A screening sample #119 after 2,936 minutes of test time. No visible cracking or pitting

Silicone based elastomers were a promising category of materials given their high primary bond strength. Two materials were tested in this category. The first was a standard RTV silicone from GE Plastics. Although visual inspection of the erosion resistance was positive, once again, water absorption masked any reasonable data. It was also determined that this material was not abrasive resistant enough for actual in-service application. The second material was Biocoat-A from Analytical Services and Materials, Inc. It is marketed as an erosion and abrasion resistant coating for marine environments. The manufacturer applied the samples to an aluminum substrate at a thickness of 0.010". The average erosion rate of samples #129 and #142 was 2.8 $\mu\text{m/hr}$. Visible cracking, pitting or other failure signs were not apparent in any of the samples tested as shown in Figure 5.15.

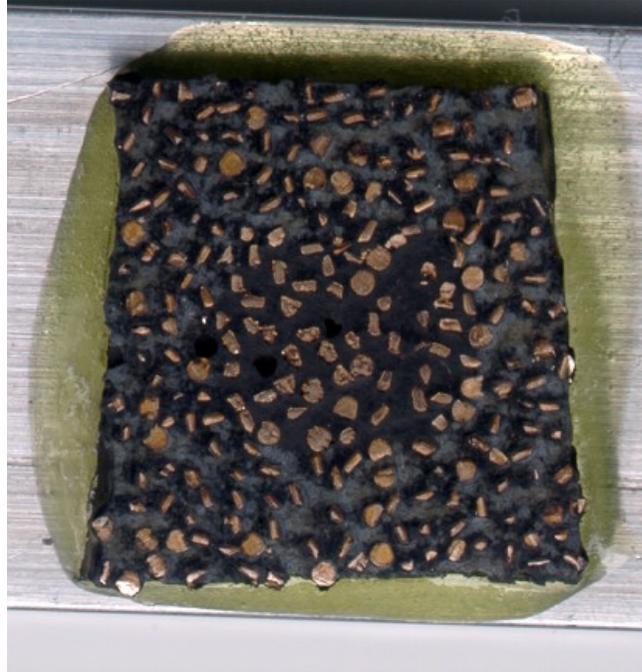
Figure 5.16 – Cuproprene sample showing damage to embedded copper-nickel granules

Cuprorene is manufactured by Dunlaw Engineering Limited and consists of a monolayer of cupro-nickel granules embedded and chemically bonded in a polychloroprene rubber sheet. The material is used primarily on submerged and splash zone structures for its anti-fouling capabilities. The material is available in sheet form and was bonded to an aluminum substrate using a two-part epoxy. The single sample erosion rate of 9.5 $\mu\text{m/hr}$ represents mass loss in the cupro-nickel granules as shown in Figure 5.16. The rubber sheet showed little sign of cavitation damage.

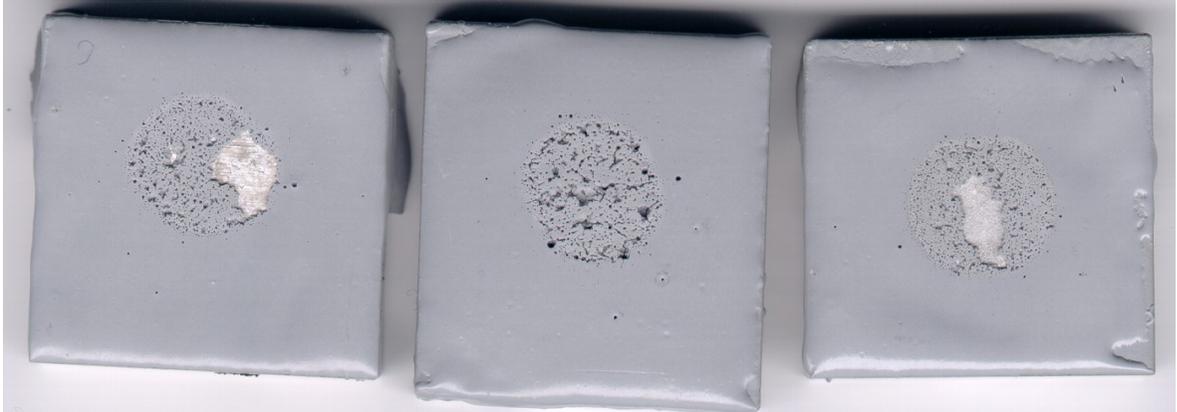
Figure 5.17 – Tested samples of CeRam-Kote 54 on aluminum substrates showing cavitation damage

and resulted in an erosion rate of 159 $\mu\text{m/hr}$ from samples #074 and #075. Severe pitting and material loss as shown in Figure 5.17 characterized the ceramic failure.
