## **THE EFFECT OF SHOT PEENING ON THE CAVITATION EROSION OF PURE IRON AND AUSTENITIC STAINLESS STEEL IN DISTILLED AND 1% SALT WATERS**

### **Summary**

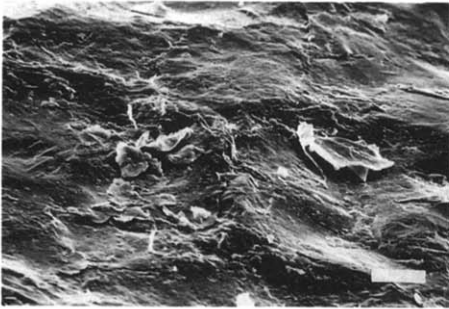
Shot peening increased the surface hardness of the iron and stainless steel by about 100% and 70% respectively and affected the metal to a depth of at least 0.30 mm in both cases (Fig. 1). The surface roughnesses of the peened metals are shown in Figs. 2 and 3 and the presence of surface debris on the iron (Fig. 2) should be noted. A section of the peened iron surface showing the nature of the surface debris in more detail is presented in Fig. 4. The figure also shows the uniform annealed grains of the untreated iron (see

**Fig. 2.** Surface topography of shot-peened pure iron. Marker 50  $\mu\text{m}$ .

A feature of the effect of shot peening on the cavitation erosion of iron in both distilled and salt waters is the initial faster erosion rate of the peened iron compared with the unpeened iron (Figs. 5 and 6). This is considered to be due to the extended laps and surface debris on the iron (Figs. 2 and 4) which will be easily detached during cavitation erosion. The effect of shot peening on the cavitation damage of iron in both distilled and salt waters reduces the damage by only a factor of about 0.7 times (Table 1).
